NAVAL WEAPONS CENTER CHINA LAKE CALIF
COSO GEOTHERMAL CORROSION STUDIES.(U)

Coso Geothermal Corrosion Studies

by
Stephen A. Finnegan
Research Department

OCTOBER 1977

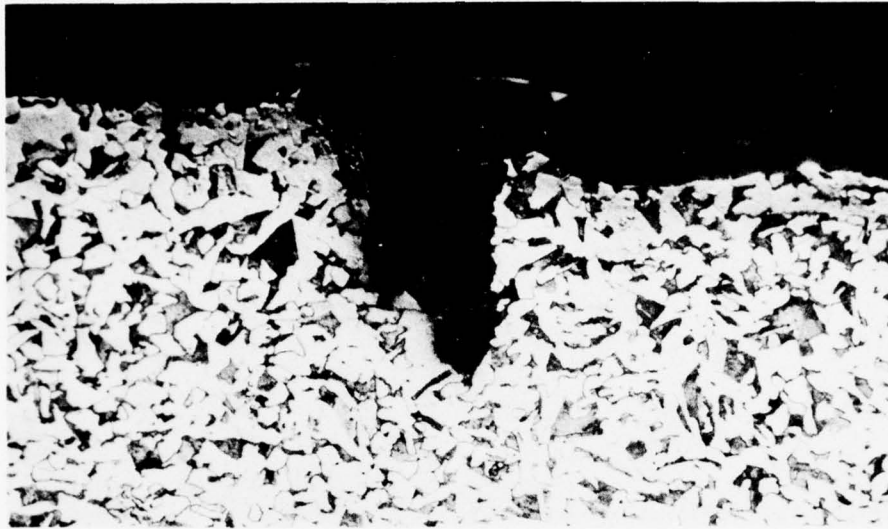
FIGURE 3. A Photomicrograph Showing Pitting Corrosion in Steel Exposed to Anaerobic Acid-Sulfate Steam. (200X)

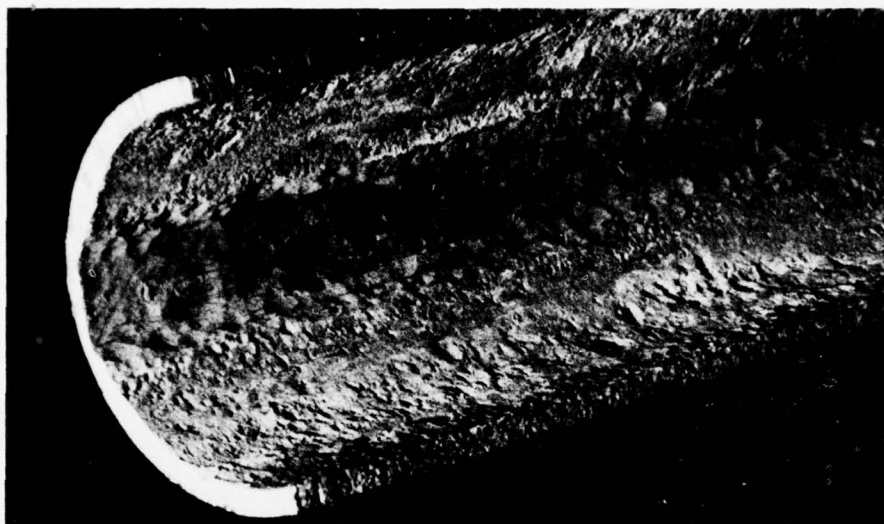
FIGURE 5. A Corrosion Channel in the Bottom of the Pipe Described in Figure 4, After Cleaning.

adjacent to the metal. This passivating layer plus the limited amount of moisture that collected on the walls resulted in a reduced corrosion rate relative to the condensate channel, which was well soaked with acid condensate. The presence of added moisture in this latter area also resulted in the formation of a thick, loose layer of hydrated ferric oxides next to the metal which were less protective and allowed corrosion to continue relatively unencumbered. The corrosion channel was filled entirely with this corrosion product. Above it was a very thick, loose, highly porous layer composed of a mixture of magnetite and maghemite, which in turn was capped with a coherent thin coating of hematite. This layering sequence resulted from differences in oxidation conditions, each layer reflecting the amount of moisture and oxygen present in that zone. The layer adjacent to the metal formed in a wet atmosphere containing a limited amount of oxygen while the outer layer was formed in a well aerated atmosphere. The magnetite represents an intermediate oxide, and forms generally in an oxygen-poor environment. The formation of large quantities of relatively insoluble corrosion products in the condensate channel eventually trapped and pooled the condensate plus all of the various solid and dissolved contaminants and soluble reaction products which resulted in a more concentrated acid environment (probably a more defective coating of oxidation products) and, consequently, more extensive corrosion of the floor of the channel.

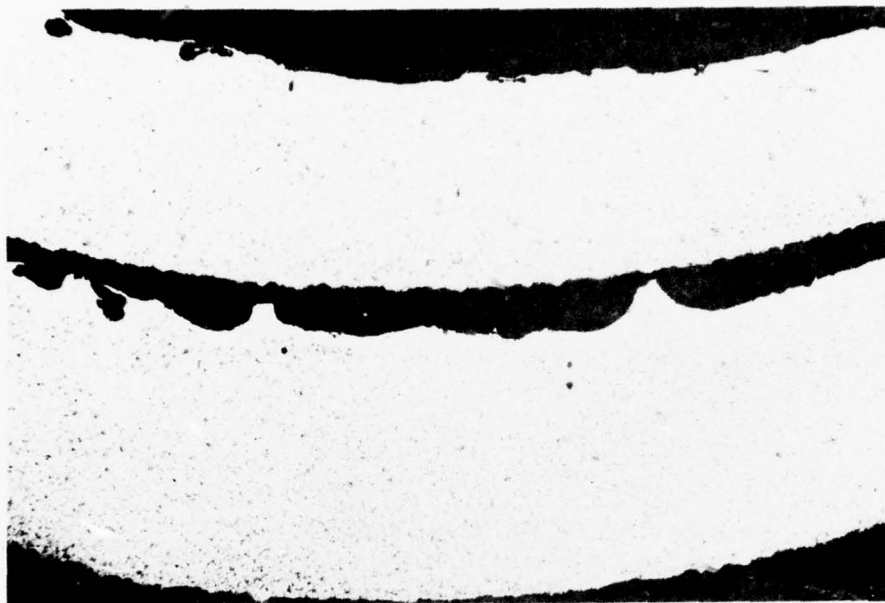
FIGURE 6. A Section View of Gray Cast Iron Exposed to Anaerobic, Acid-Sulfate Steam, Showing Surface Irregularities.

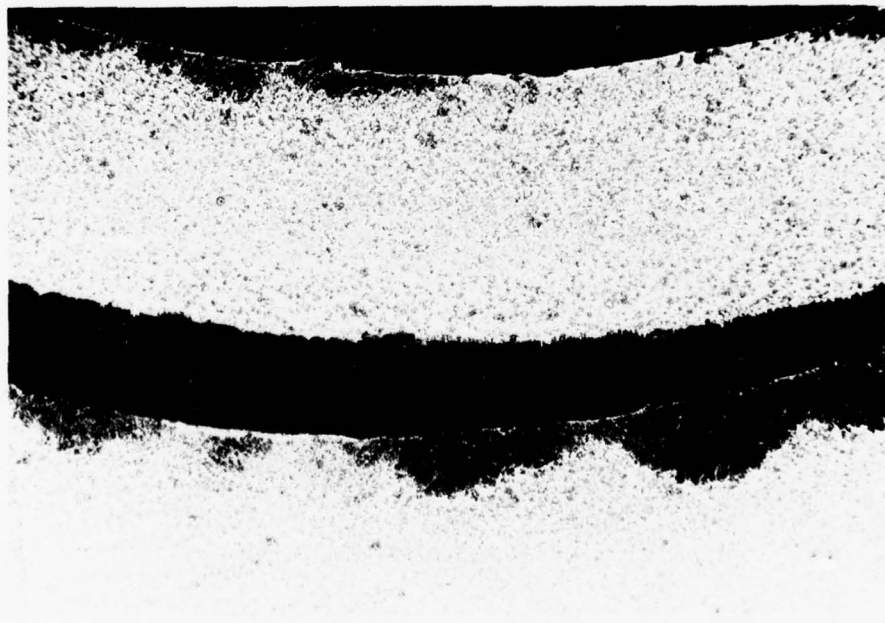
The aerated specimen was covered with a layer of ferric oxides and hydrated oxides identical in appearance to those found on the steel pipe, only considerably thinner in depth. Corrosion of the cast iron underneath was low and quite uniform within the condensate channel. No corrosion channel was formed on the bottom as on the steel pipe although the normally rough cast iron surface was leveled and smoothed by the corrosion process. A possible graphite-rich zone about 1.8 mm deep was found next to the surface in the cast iron on the bottom of the condensate channel near the downstream end (Figure 7). An analysis of the

FIGURE 7. A Section View of Gray Cast Iron Exposed to Aerated, Acid-Sulfate Steam, Showing a Zone of Possible Graphitization Next to the Surface.

microstructure did not reveal whether the zone was due to corrosion of the iron phase (graphitization) or simply an agglomeration of graphite particles. A sample of wall material was analyzed with x-ray fluorescence which discovered an excess of silicon in these soft black-colored areas. The presence of carbon could not be verified with this method. Adjacent microstructure contained predominantly type D graphite flakes (Figure 8) which would indicate some degree of undercooling.²⁹ The material at the surface also showed evidence of possible chilling. This specimen clearly needs additional study. The graphitization of gray cast iron in a dilute sulfuric acid solution has been observed previously²⁶ and appears to proceed if the graphite phase remains exposed to the attacking fluid. Attack generally stops or slows once the graphite becomes covered with corrosion products.

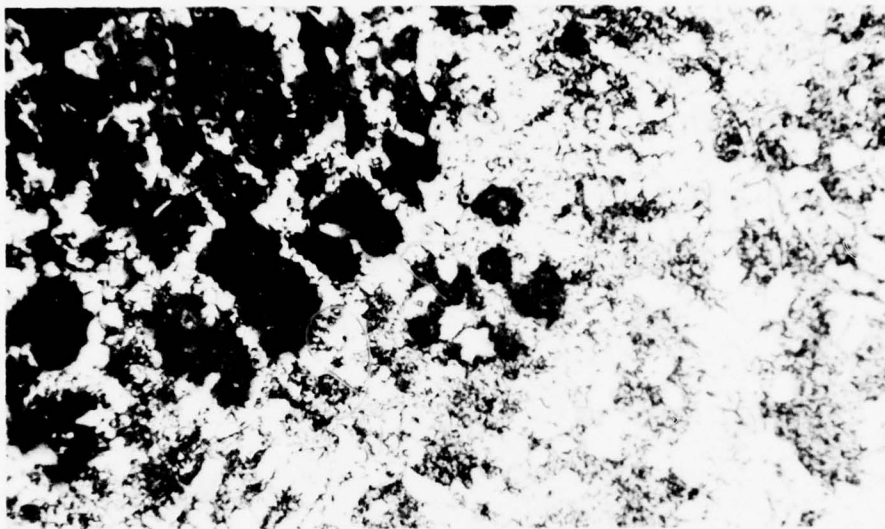
FIGURE 8. A Photomicrograph of the Specimen Shown in Figure 7, Indicating Possible Graphitized Areas (dark) and Adjacent Microstructure. (100X)

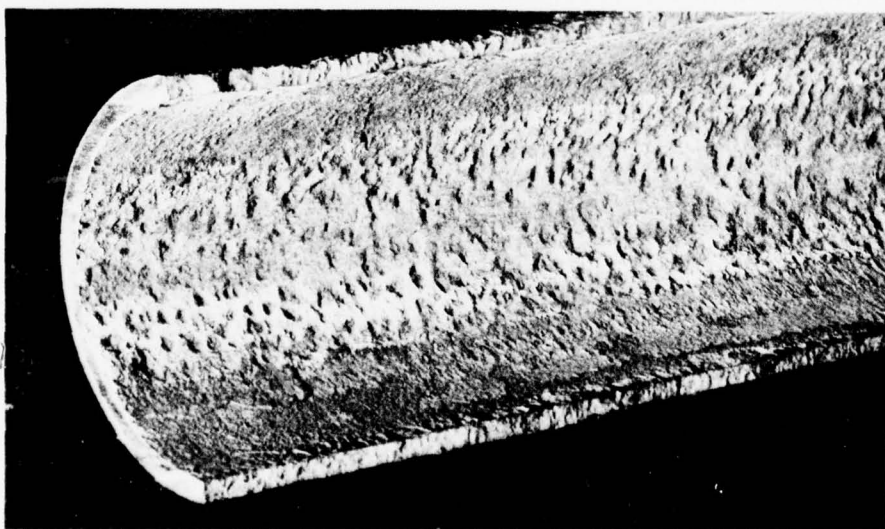
FIGURE 9. Outlet End of an Open, Galvanized Steel Pipe Exposed to Aerated Acid-Sulfate Steam, Showing Pitting Corrosion.

particularly in the downstream portion. On the walls above the water line, corrosion was generally uniform although a few large, very shallow pits up to 0.1 mm deep were observed near the top of the walls. Prior to cleaning, the surfaces (particularly within the condensate channel) were covered with an extensive coating of ferric oxides plus some β -zinc sulfide and zinc oxide directly covering the bare zinc at the upstream and downstream ends, respectively.

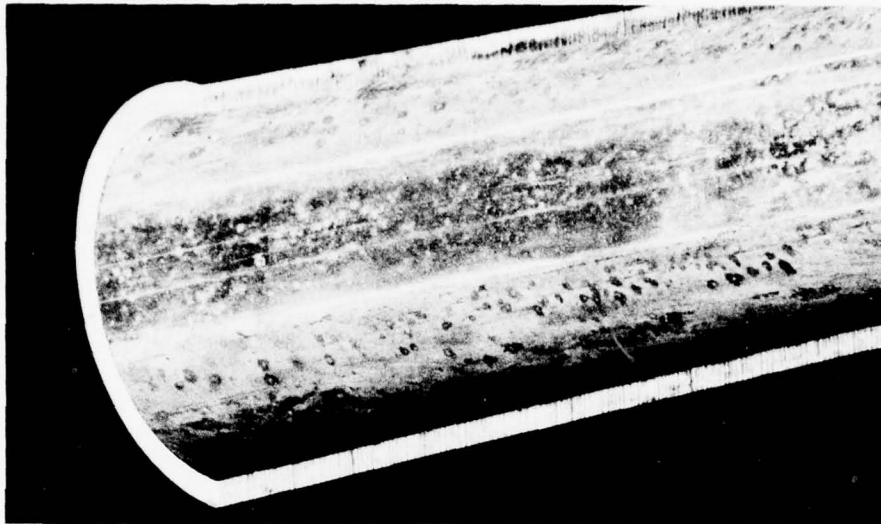
FIGURE 10. Outlet End of an Open Aluminum Pipe Exposed to Aerated Acid-Sulfate Steam, Showing Pitting Corrosion on the Walls Under a Thin Film of Brown Precipitates.

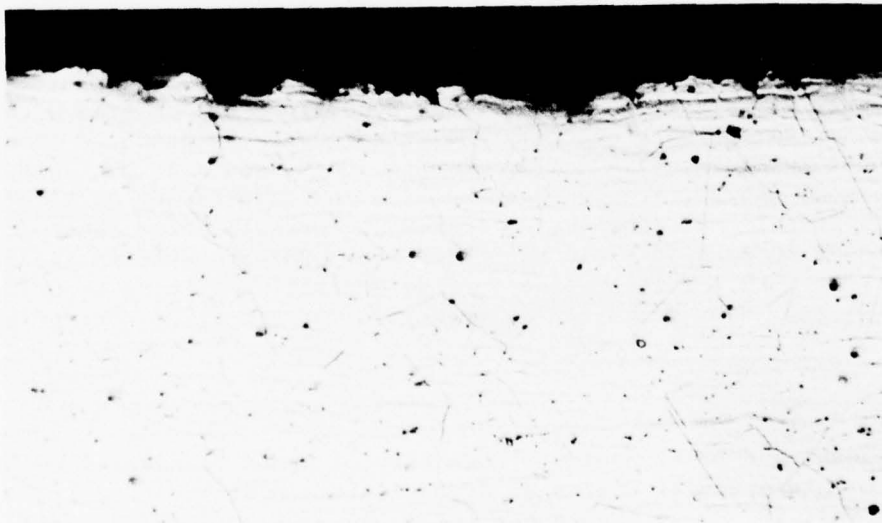
FIGURE 11. A Photomicrograph Showing Minor Pitting Corrosion and Grain Boundary Attack of a Stainless Steel Pipe Exposed to Aerated, Acid-Sulfate Steam. (200X)

oxygen to the surface of the metal. In addition to pitting, the surface showed minor attack to grain boundaries (Figure 11).

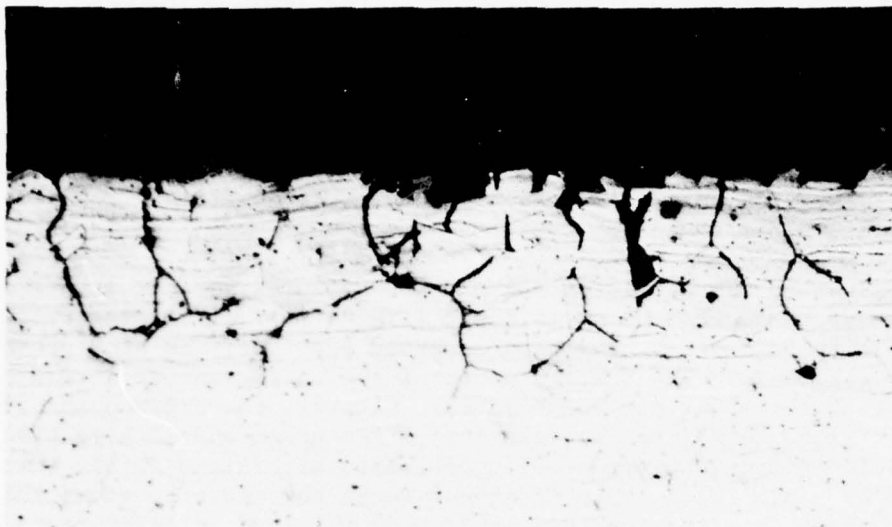
FIGURE 12. A Photomicrograph Showing Intergranular Corrosion Adjacent to a Welded Seam in the Sample Described in Figure 11. (200X)

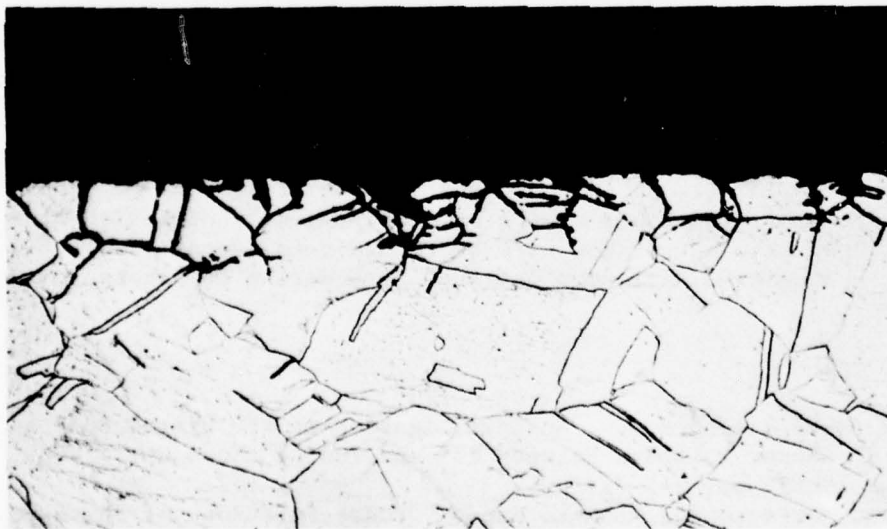
FIGURE 13. A Photomicrograph Showing Intergranular Corrosion of a Copper Tube Exposed to an Anaerobic, Acid-Sulfate Steam. (200X)

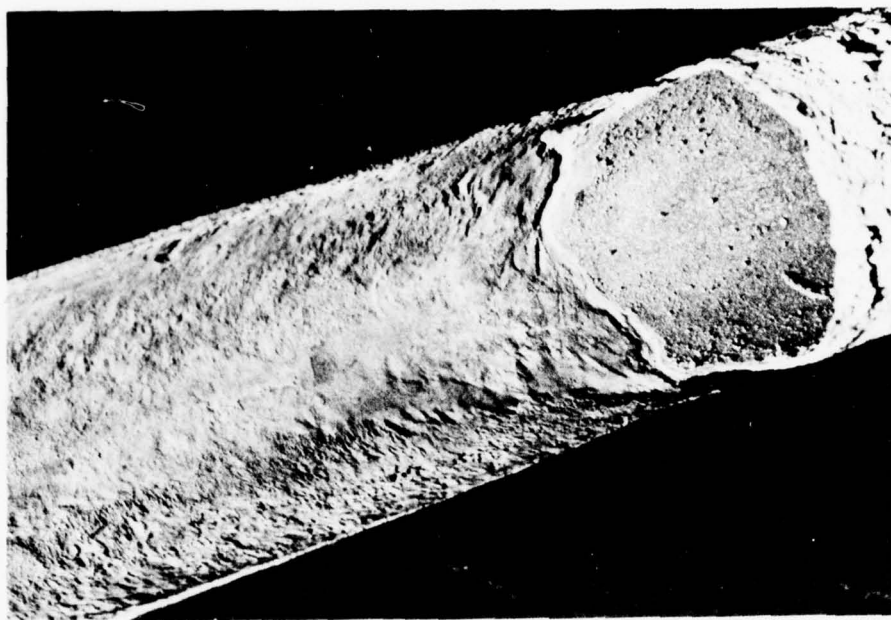
FIGURE 14. Inlet End of an Open Copper Pipe Exposed to an Aerated, Acid-Sulfate Steam, After Cleaning.

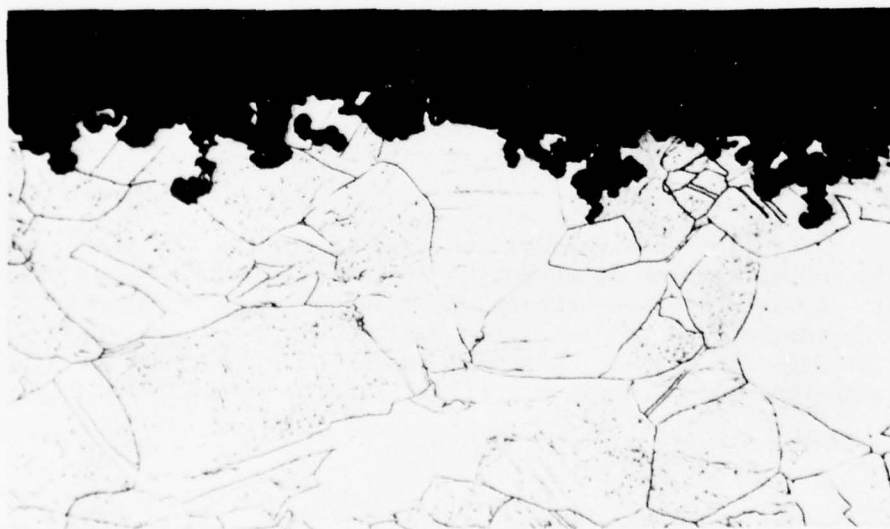
FIGURE 15. A Photomicrograph Showing Pitting Corrosion of an Open Copper Tube Exposed to an Aerated, Acid-Sulfate Steam. (200X)

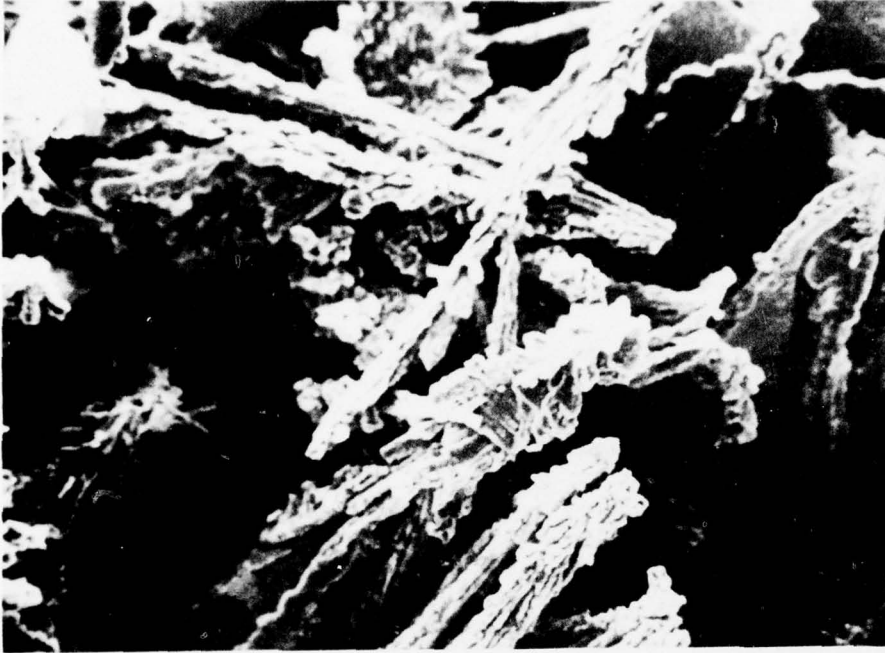
FIGURE 16. A scanning Electron Microscope Photomicrograph of Dendritic Structure Found in Corrosion Products Removed From the Specimen Shown in Figure 14, Tentatively Identified as Recrystallized Copper. (1700X)

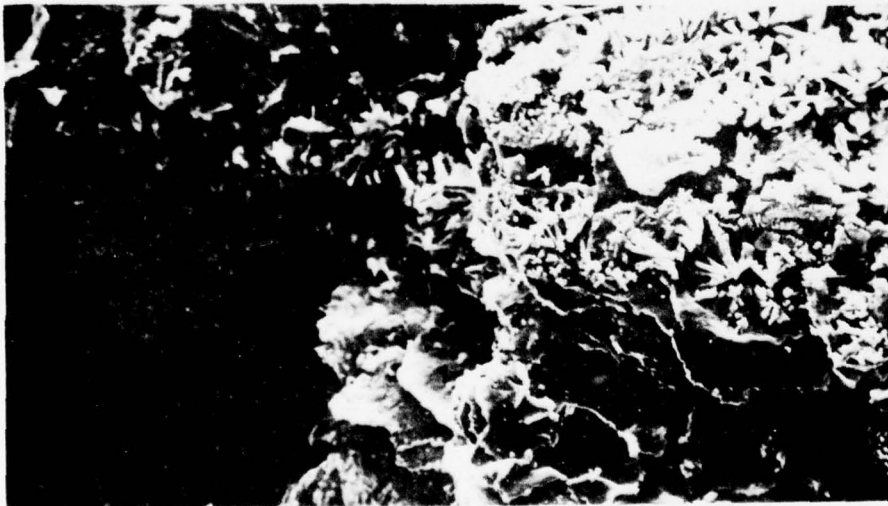
FIGURE 17. A Scanning Electron Microscope Photomicrograph of Sheet-Like Crystals Found in Corrosion Products Removed From the Specimen Shown in Figure 14, Tentatively Identified as Bladed Covellite, CuS . (330X)

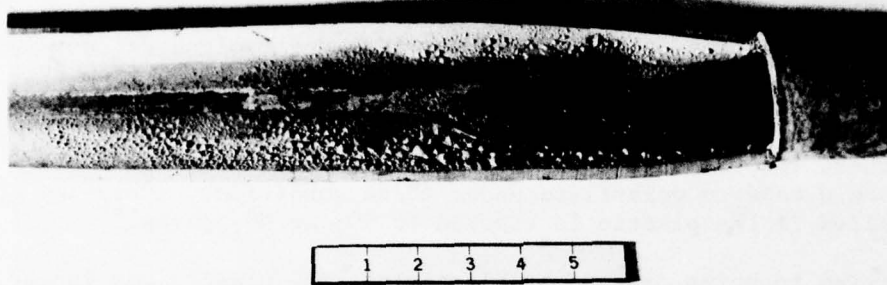
FIGURE 18. Inlet End of an Open PVC Pipe Exposed to an Aerated, Acid-Sulfate Steam, Showing Blistering of the Surface. Flow is from right to left. Scale in inches.

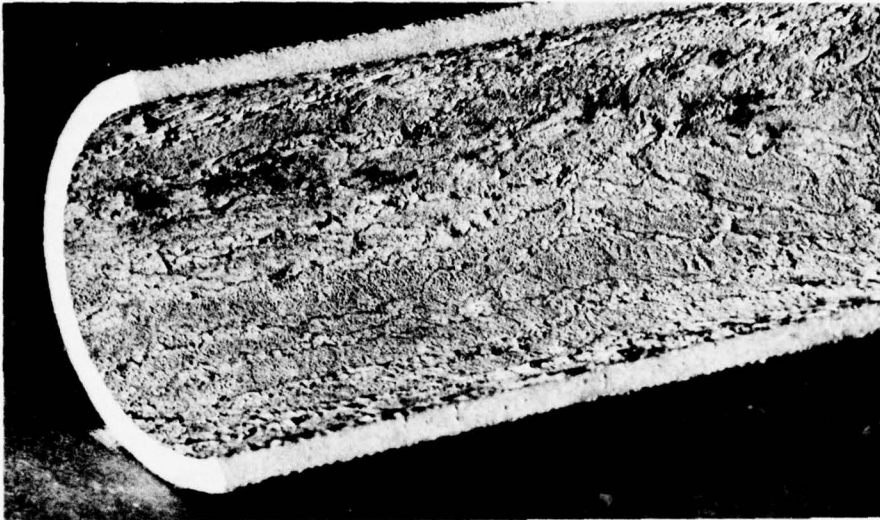
FIGURE 19. Outlet End of an Open Gray Cast Iron Pipe Exposed to Aerated Groundwater-Diluted Steam, After Cleaning, Showing Surface Grooves.

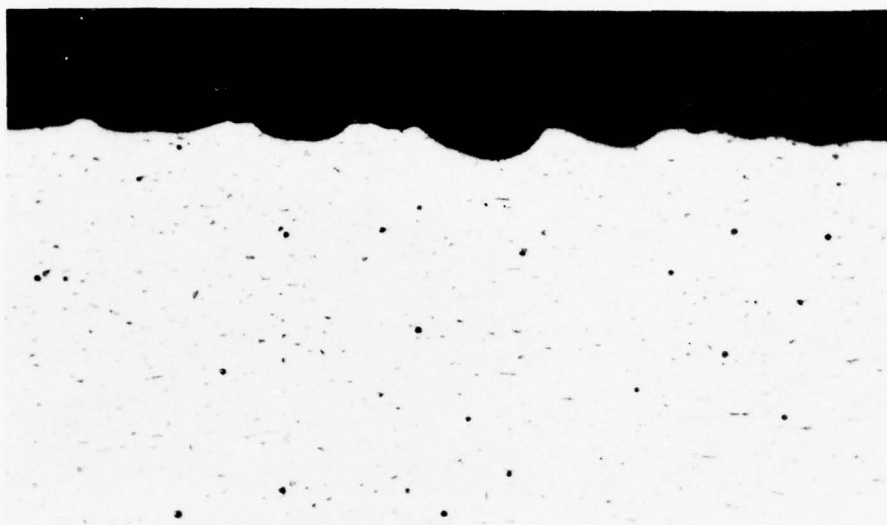
FIGURE 21. A Photomicrograph Showing Pitting Corrosion in an Open Aluminum Pipe Exposed to Aerated Groundwater-Diluted Steam. (200X)

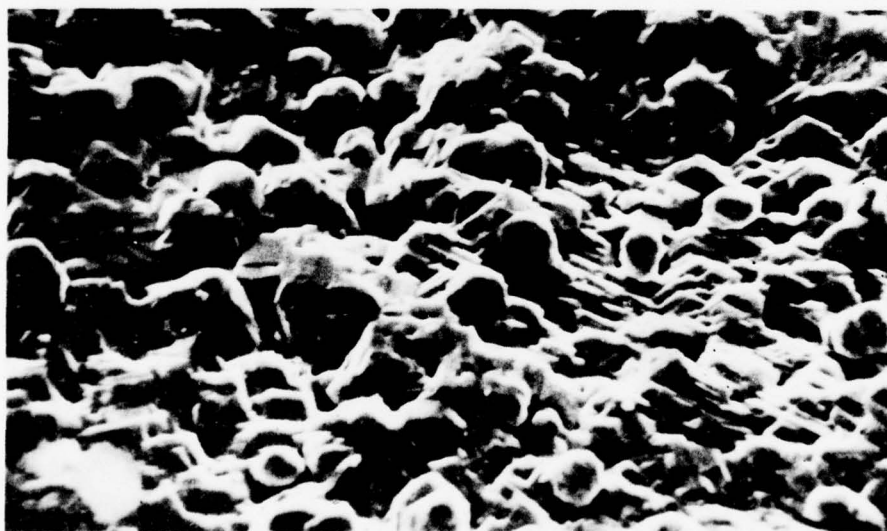
FIGURE 22. A Scanning Electron Microscope Photomicrograph of Silver-Gray, Plate-Like Sulfide Corrosion Products in a Closed Copper Tube Exposed to Anaerobic Groundwater-Diluted Steam, Identified as Cu_2S , Chalcocite. (320X)

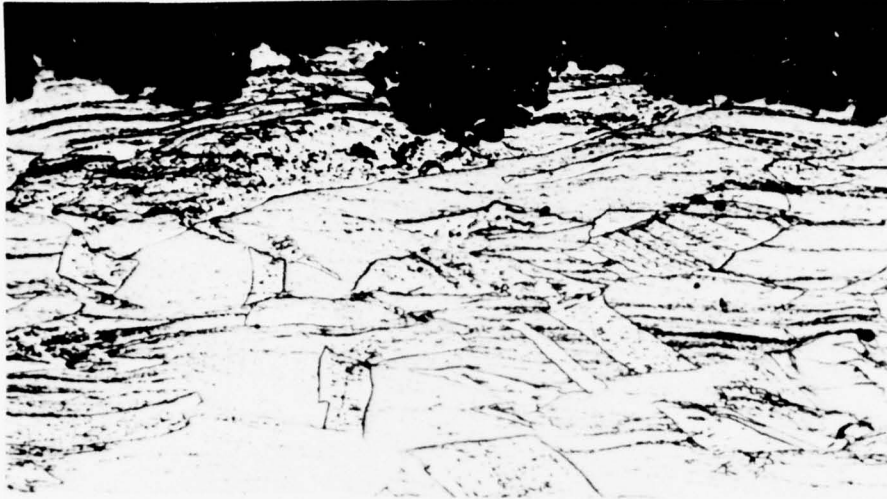
FIGURE 23. A Photomicrograph Showing Pitting Corrosion in an Open Copper Pipe Exposed to Aerated Groundwater-Diluted Steam. (200X)

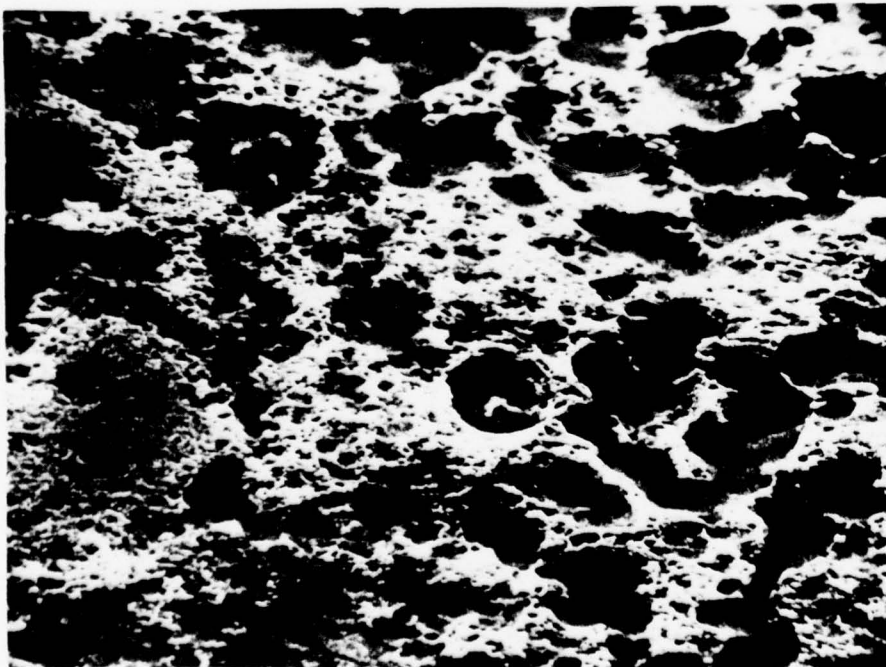
FIGURE 24. A Scanning Electron Microscope Photomicrograph Showing Pitting Corrosion of the Copper Specimen Described in Figure 23. (210X)

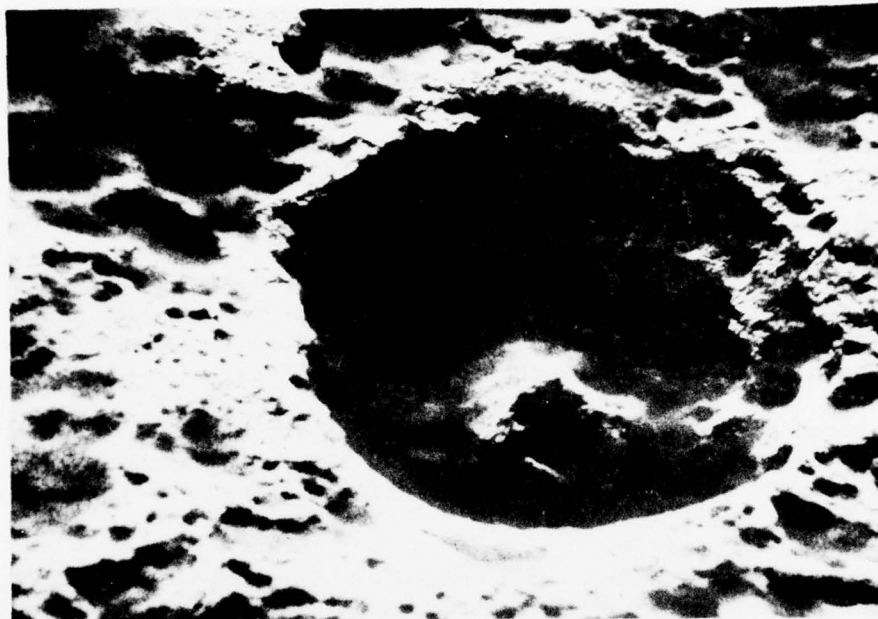
FIGURE 25. A Scanning Electron Microscope Photomicrograph Showing the Bottom of a Pit Viewed in Figure 24. (1060X)

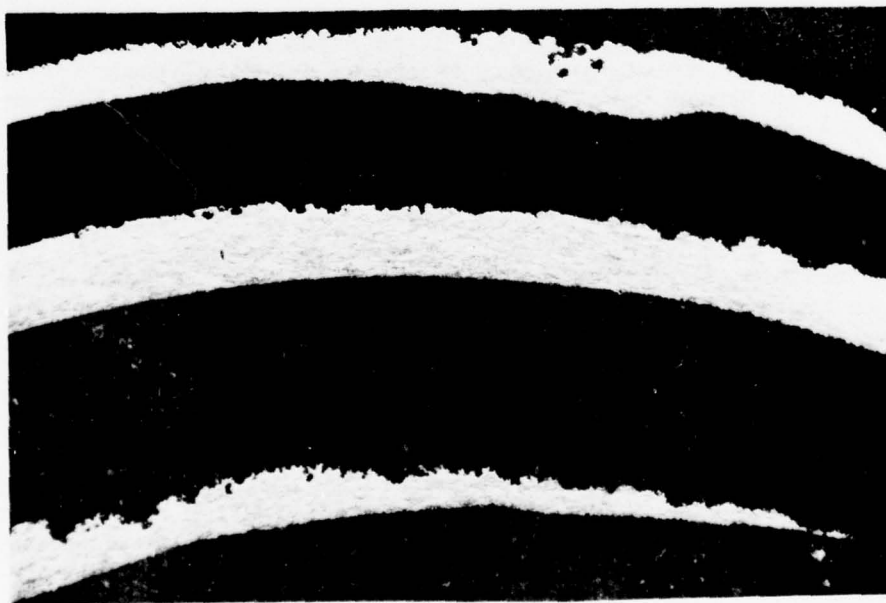
FIGURE 26. A Section View of the Specimen Described in Figure 23 Showing Pitting Corrosion of the External Copper Surface.

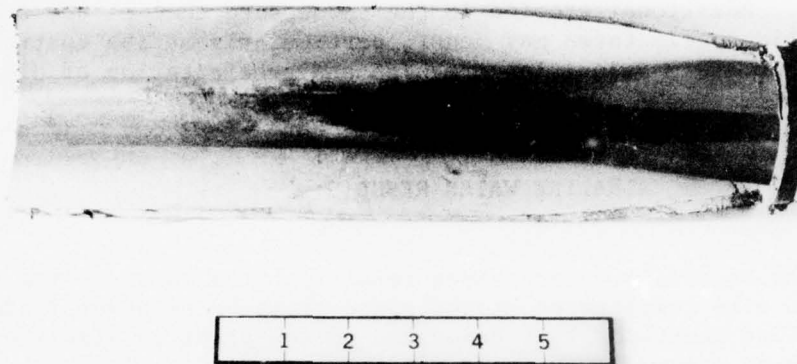
The aerated pipe at its upstream end was discolored on the inner surface and showed some blistering identical to that found in the closed pipe. The pipe in this region showed some effects of softening similar

FIGURE 27. Inlet End of an Open PVC Pipe Exposed to Aerated Groundwater-Diluted Steam. Flow is from right to left. Scale in inches.

to those observed previously for this material. In addition to blistering, some crazing of the surface was observed on the walls above the condensate channel in areas covered with a thin film of gray precipitates. The precipitate was not identified, although it appeared to be primarily an iron sulfide-oxide mixture.

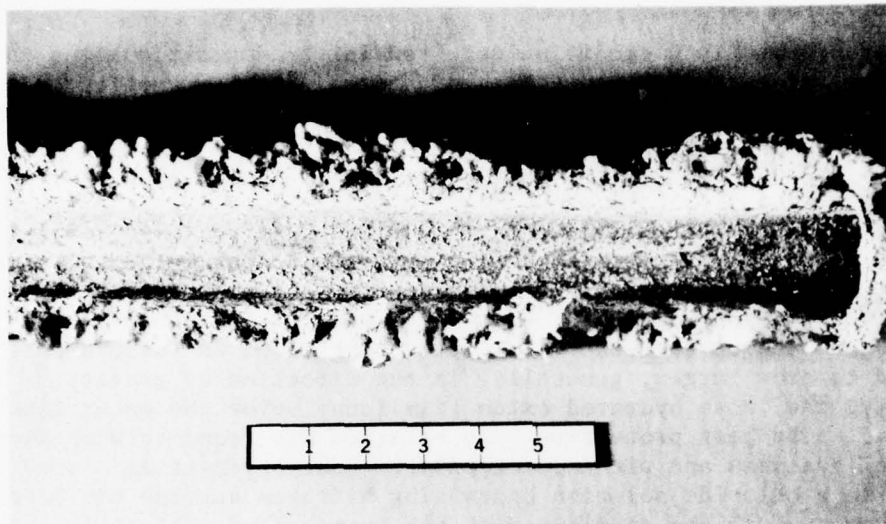
FIGURE 28. Inlet End of an Open Aluminum Pipe Exposed to Hot Aerated Alkaline Water Showing Sodium Chloride Precipitation. Flow is from right to left. Scale in inches.

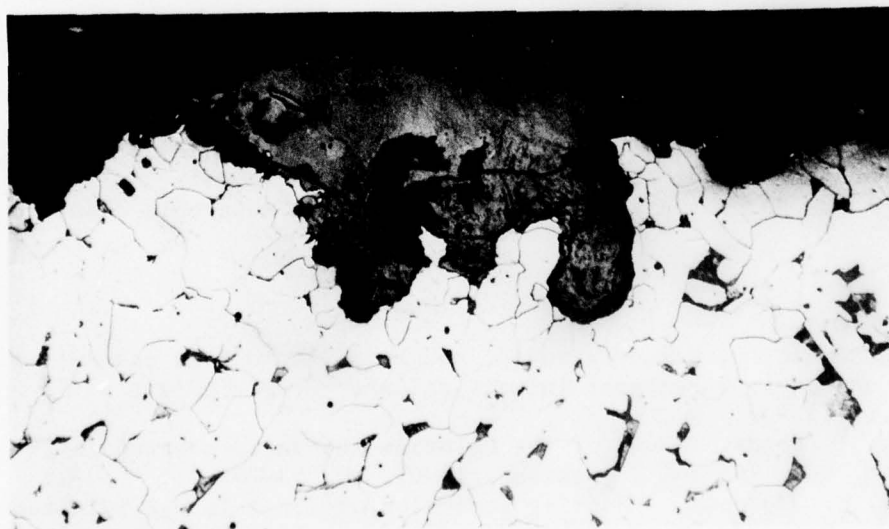
FIGURE 29. A Photomicrograph Showing Pitting Corrosion in a Closed Steel Pipe Exposed to Hot, Anaerobic Alkaline Fluids. (200X)

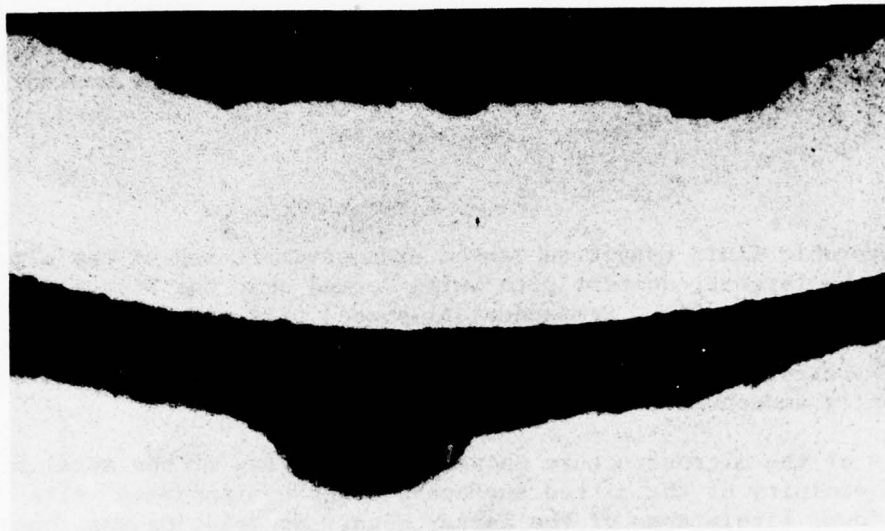
FIGURE 30. A Section View of an Open Steel Pipe Exposed to Hot, Aerated Alkaline Fluids Showing Pitting Corrosion.

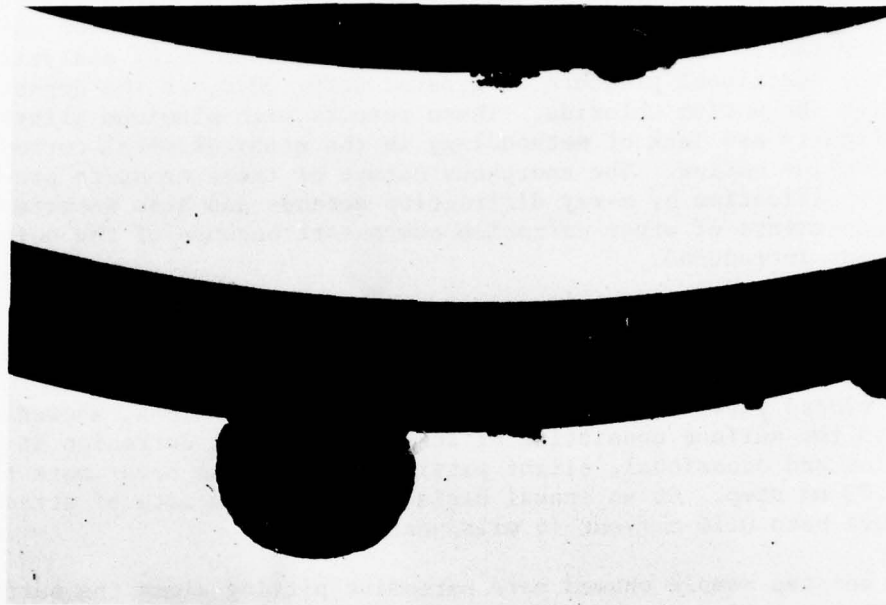
FIGURE 31. A Section View of a Closed Aluminum Pipe Exposed to Hot, Anaerobic Alkaline Fluids, Showing Pitting Corrosion.

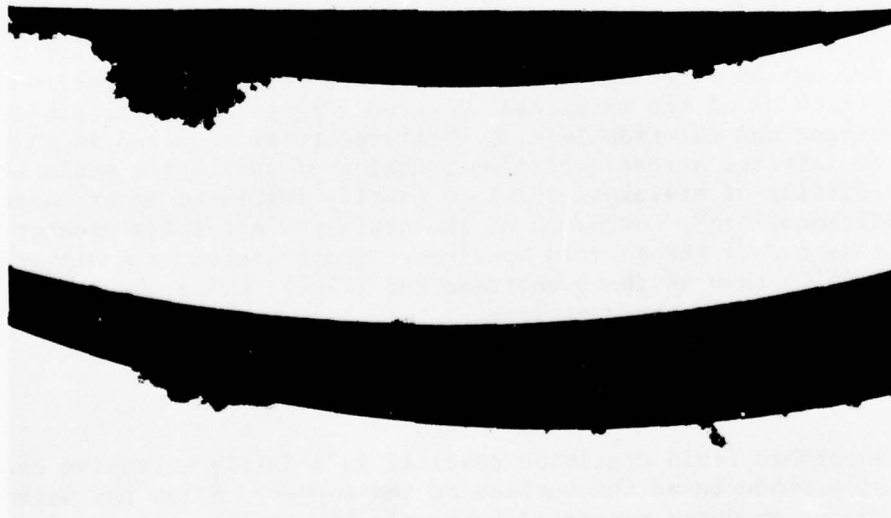
FIGURE 32. A Section View of an Open Aluminum Pipe Exposed to Hot, Aerated Alkaline Fluids, Showing Pitting Corrosion.

The salt deposits found on the aerated aluminum specimen proved difficult to remove, in contrast to those found on other specimens which flaked off easily or readily dissolved in water. An x-ray analysis showed the additional presence of gypsum, $\text{CaSO}_4 \cdot 2\text{H}_2\text{O}$, in the deposit, along with the sodium chloride. These results with aluminum illustrate the difficulty and lack of methodology in the study of metal corrosion in an alkaline medium. The amorphous nature of these products prevents ready identification by x-ray diffraction methods and also interferes with measurements of other corrosion components because of the noisy backgrounds introduced.

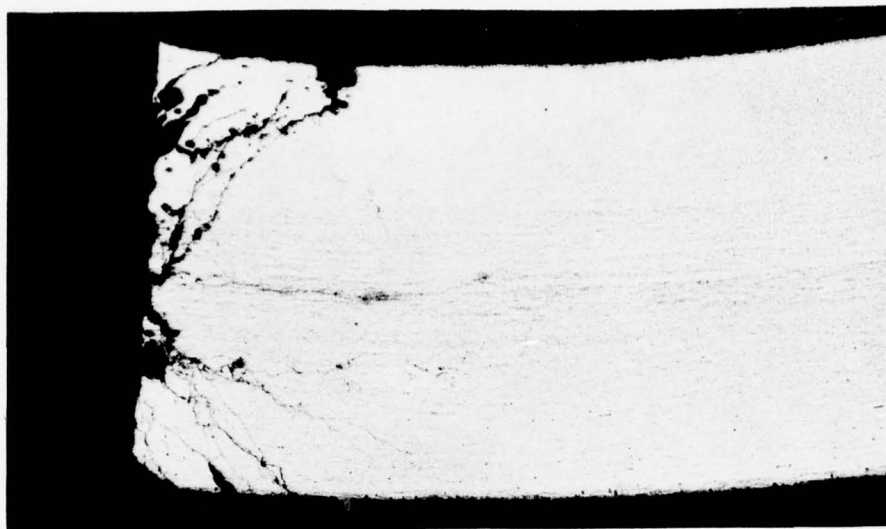
FIGURE 33. A Section View of an Open Stainless Steel Pipe Exposed to Hot, Aerated Alkaline Fluids, Showing Transgranular Stress-Corrosion Cracking.

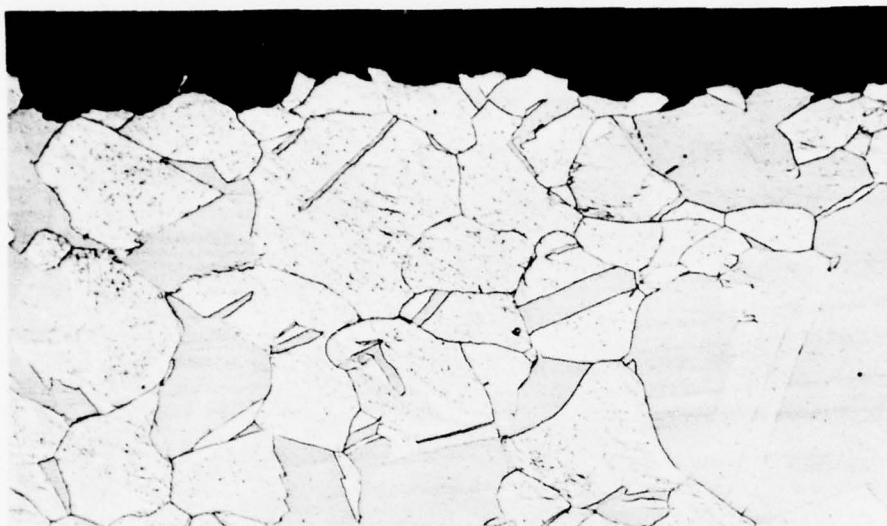
FIGURE 34. A Photomicrograph Showing Surface Corrosion of a Closed Copper Tube Exposed to Hot, Anaerobic Alkaline Fluids. (200X)

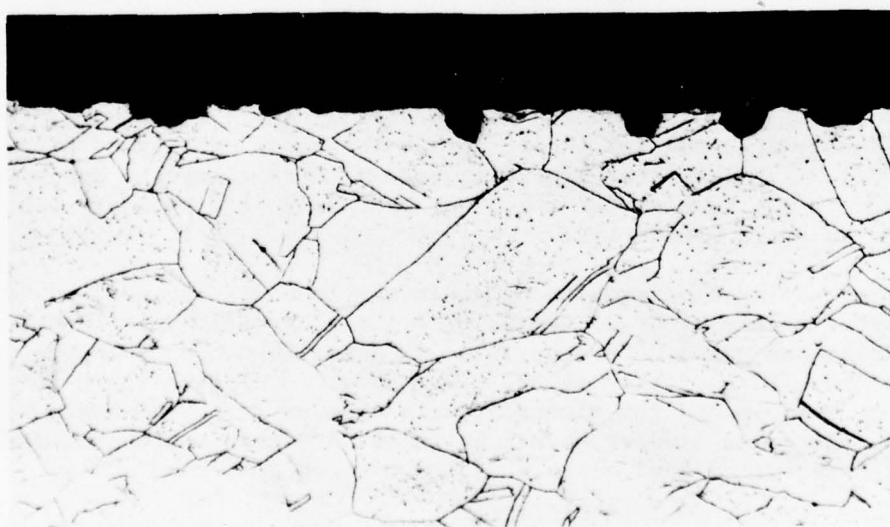
FIGURE 35. A Photomicrograph Showing Pitting Corrosion of an Open Copper Tube Exposed to Hot, Aerated Alkaline Fluids. (200X)
